BUILDING REGULATION & FIRE SAFETY ENGINEERING CONSULTANTS

Project: ASHFIELD MUNICIPAL COUNCIL
- TOWN HALL \ AUDITORIUM

Report: BCA ASSESSMENT AND AUDIT
REPORT

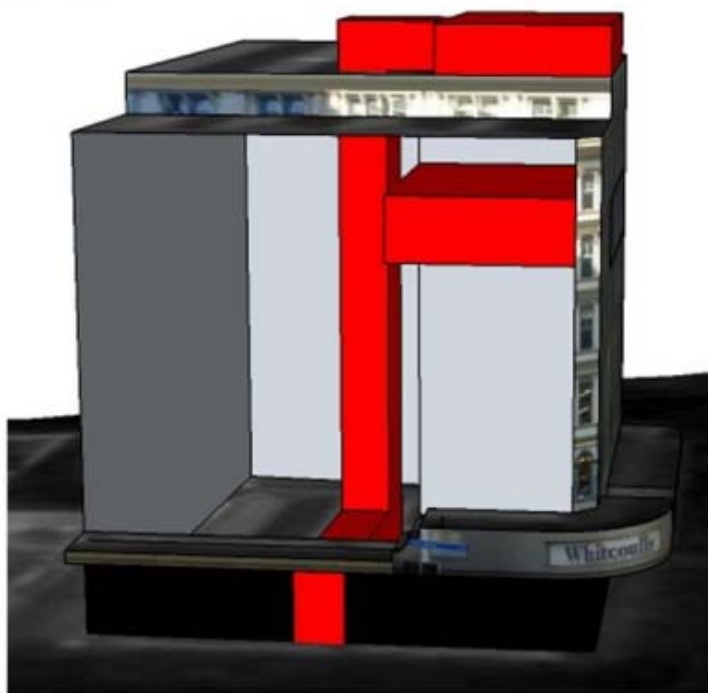
The "Affected Part" in existing buildings relates to providing an accessible path of travel from the principal public entrance to the new or modified part of an existing building. An example of this is shown in the sketch below. This shows works to two upper floors only within an existing building – the result is the upgrade of the Affected Part being the entrance and lift to access the floors being refurbished.
